TEST REPORT

NO.: ECT2019K040216-Y1

Sample name: LED street light

According to customer requirements, to do IK09 test on the submitted sample(s).

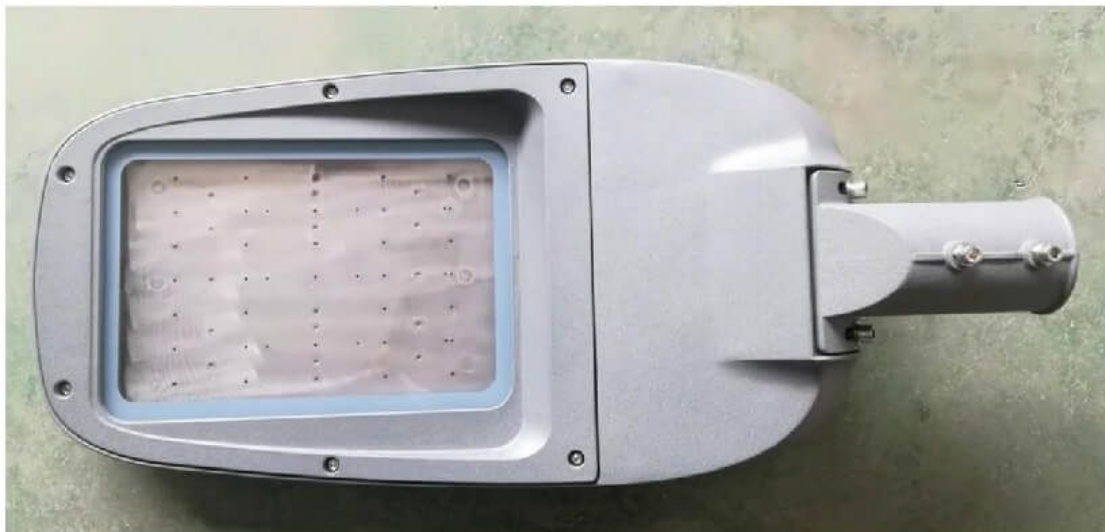
Photos of the sample:

Test Item	Criteria (According to the technical requirements of client)	Test Result	
IK09	No crack on the sample	After the test, there is no obvious appearance abnormality on the sample.	P

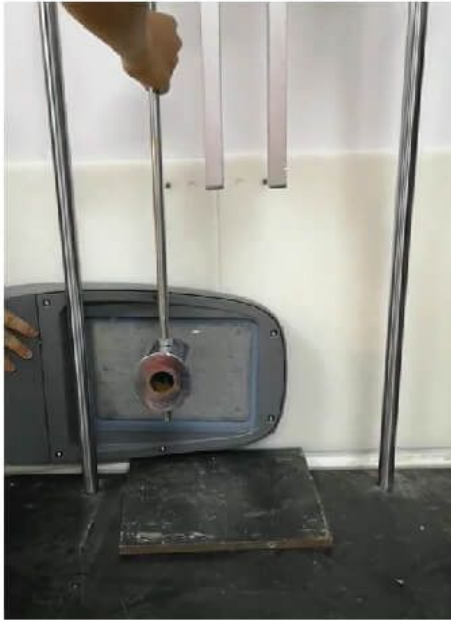
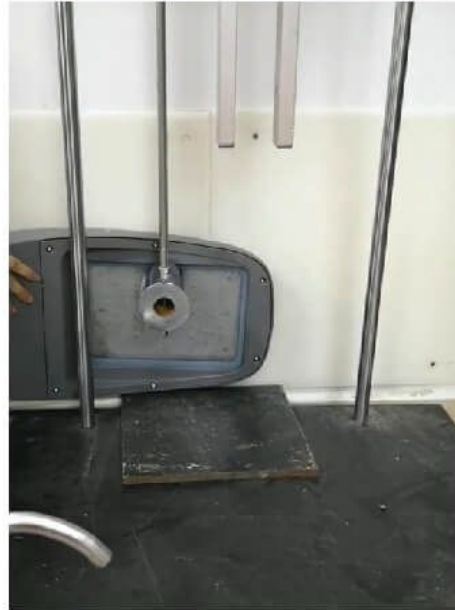
Photos of the Testing:

- 1) Ambient temperature and relative humidity: 23.5°C, 58% RH
- 2) Test condition:
 - a) Place the sample lean on the wall, drop the pendulum bob which weight is 5 kg to impact the sample from a height of 200 mm, the impact energy is 10J.
 - b) The impact point is uniformly distributed on the sample
 - c) Check the samples after test
